**Re: Official Information Act request – Asbestos management plans**

## Asbestos Management Plan

Unique Identifier	HS01/ASD/015 - v01.00
Document Type	Policy
Risk of non-compliance	may result in significant harm to the patient/DHB
Function	Administration, Management and Governance
User Group(s)	ADHB only
• Organisation(s)	Auckland District Health Board (ADHB)
• Directorate(s)	Auckland DHB Wide
• Department(s)	Auckland DHB Generic
• Used for which patients?	n/a
• Used by which staff?	All Auckland DHB Employee
• Excluded	
Keywords	Asbestos
Author	Special Projects Manager – Facilities and Development
Authorisation	
• Owner	Chief Executive & Endorsed by The Board
• Delegate / Issuer	<ul style="list-style-type: none"> <li>• Chief Health Professions Officer</li> <li>• Special Projects Manager – Facilities and Development</li> </ul>
Edited by	Document Controller
First issued	26 January 2018
This version issued	26 January 2018 - issued
Review frequency	3 yearly

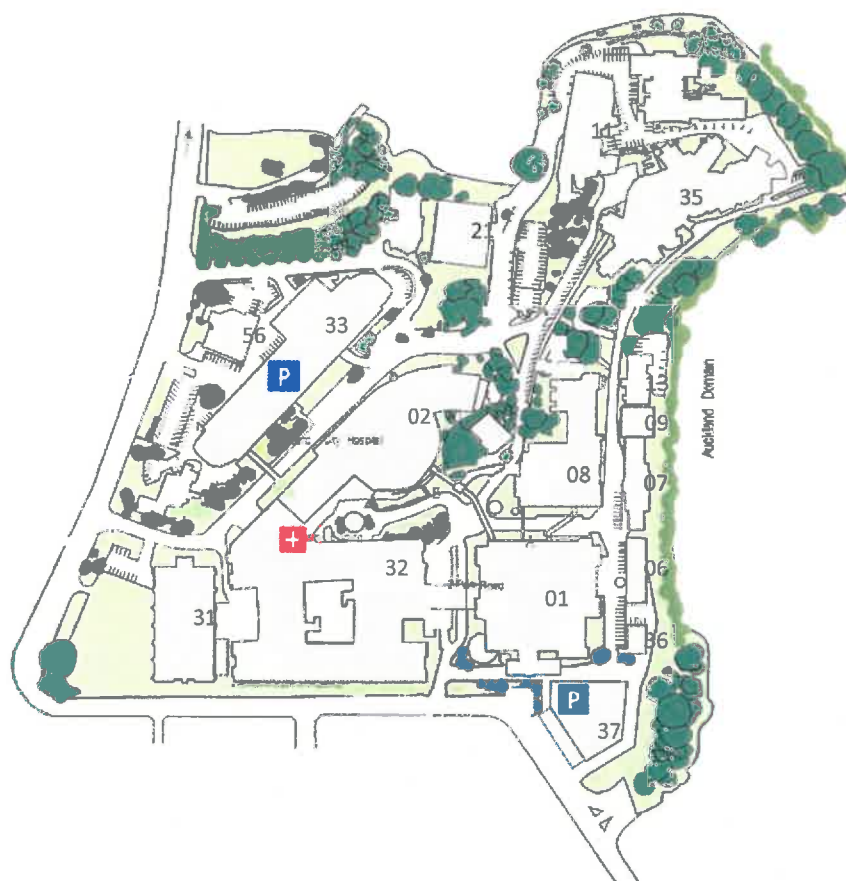
### 13.1 Auckland City Hospital Map

LEGEND					
Critical Building		Non-Critical Building		Not Applicable	
1	SUPPORT BUILDING	30	TE WHARE AWHINA – ACCOMODATION UNIT		
2	STARSHIP CHILDREN'S HEALTH	31	LABPLUS & MORTUARY		
6	BOILER HOUSE	32	AUCKLAND CITY HOSPITAL – MAIN BUILDING		
7	SUPPORT SERVICES	33	CARPARK B – HELIPAD		
8	REGIONAL CANCER & BLOOD SERVICES	35	TE WHETU TAWERA – ACUTE MENTAL HEALTH UNIT		
9	PAPU	36	SUBSTATION G		
11	RONALD McDONALD HOUSE	37	CARPARK A		
13	CLINICAL ENGINEERING	43	MARION DAVIS LIBRARY		
15	FRASER McDONALD UNIT / CRECHE	46	DANGEROUS GOODS STORE		
21	SUPPLY STORE, CLINICAL RECORDS	56	HAEMODIALYSIS UNIT

- b) **Non-Critical:** These buildings are considered either no longer fit for purpose or beyond economical maintenance and will be demolished and replaced as part of the larger site master plan. Therefore, any asbestos or ACM identified will be monitored and / or encapsulated where practical. Where it is not practical to encapsulate or it is considered that these materials may pose a health risk to building occupants or those engaged to maintain the buildings, they will be removed where practical.

- c) **Not Applicable:** These buildings have been confirmed as asbestos free and are therefore not included within the ADHB Asbestos Management Plan

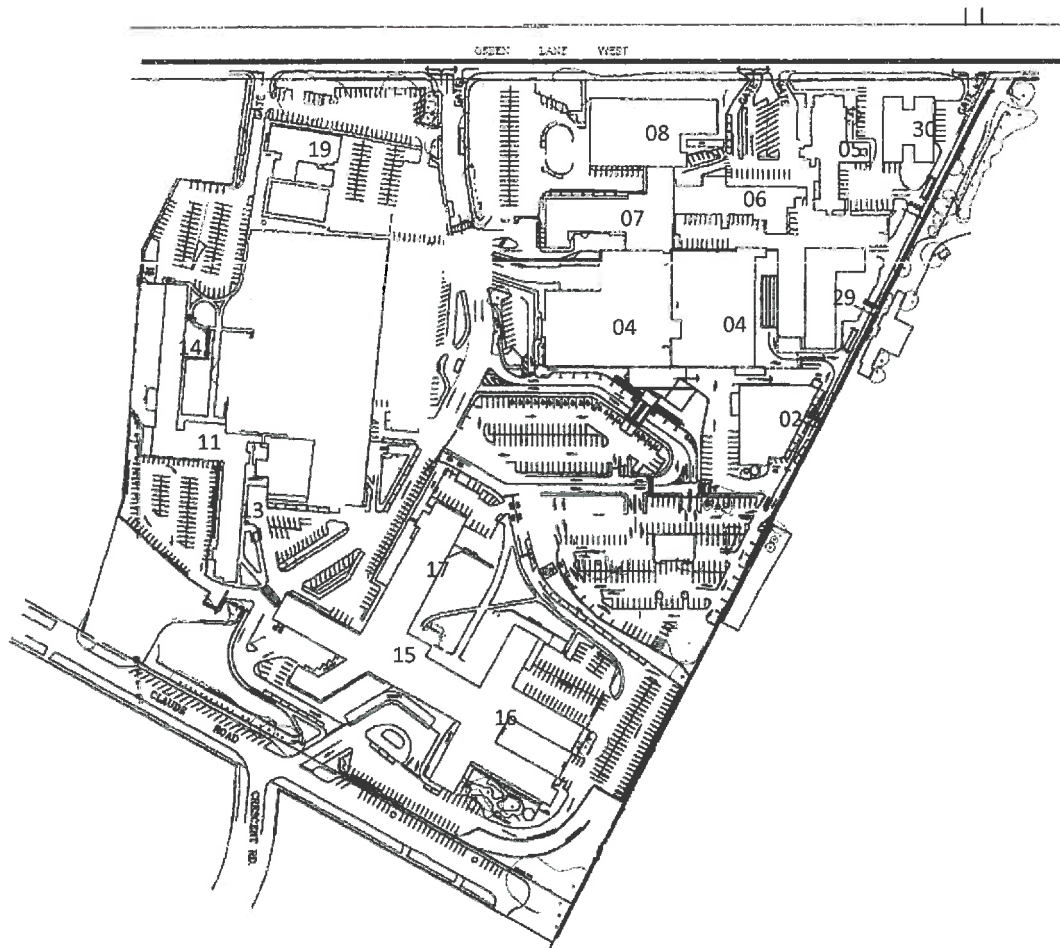
## 13.2 Greenlane Clinical Centre Site Map

<b>LEGEND</b>					
<b>Critical Building</b>		<b>Non-Critical Building</b>		<b>Not Applicable</b>	
02	MAIN BOILER HOUSE	14	ADMINISTRATION / COMMUNITY / DIALYSIS UNIT		
04	GREENLANE CLINICAL CENTRE	15	CORNWALL COMPLEX		
05	INFIRMARY WARD	16	CORNWALL COMPLEX		
06	COSTLEY BLOCK	17	CORNWALL COMPLEX		
07	CLINICAL CENTRE	19	STAFF / COMMUNITY HALL		
08	EYE CLINIC	29	CRECHE		
11	CONTACT CENTRE	30	HOME DIALYSIS UNIT		
13	STAFF RESIDENCE / ADMINISTRATION

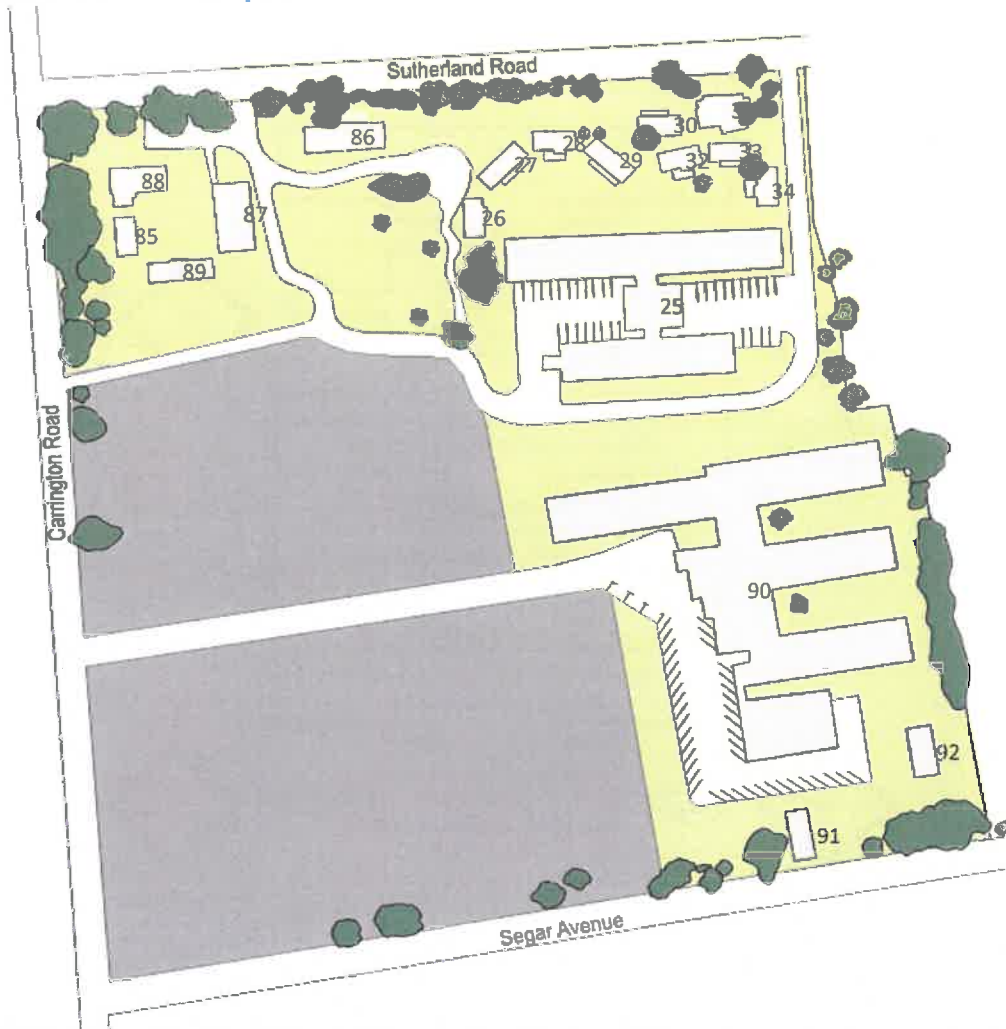
### 13.3 Point Chevalier Campus

LEGEND					
Critical Building		Non-Critical Building		Not Applicable	
25	BUCHANAN CLINIC	87	AHUERE – OFFICES		
26-34	CLUSTER HOUSING	89	WHARE KAI – DINING HALL		
86	TE IHI	90	REHAB PLUS		
85	ABLUTION BLOCK	91	REHAB PLUS HOUSING		
88	MANAWANUI MEETING HOUSE	92	REHAB PLUS HOUSING

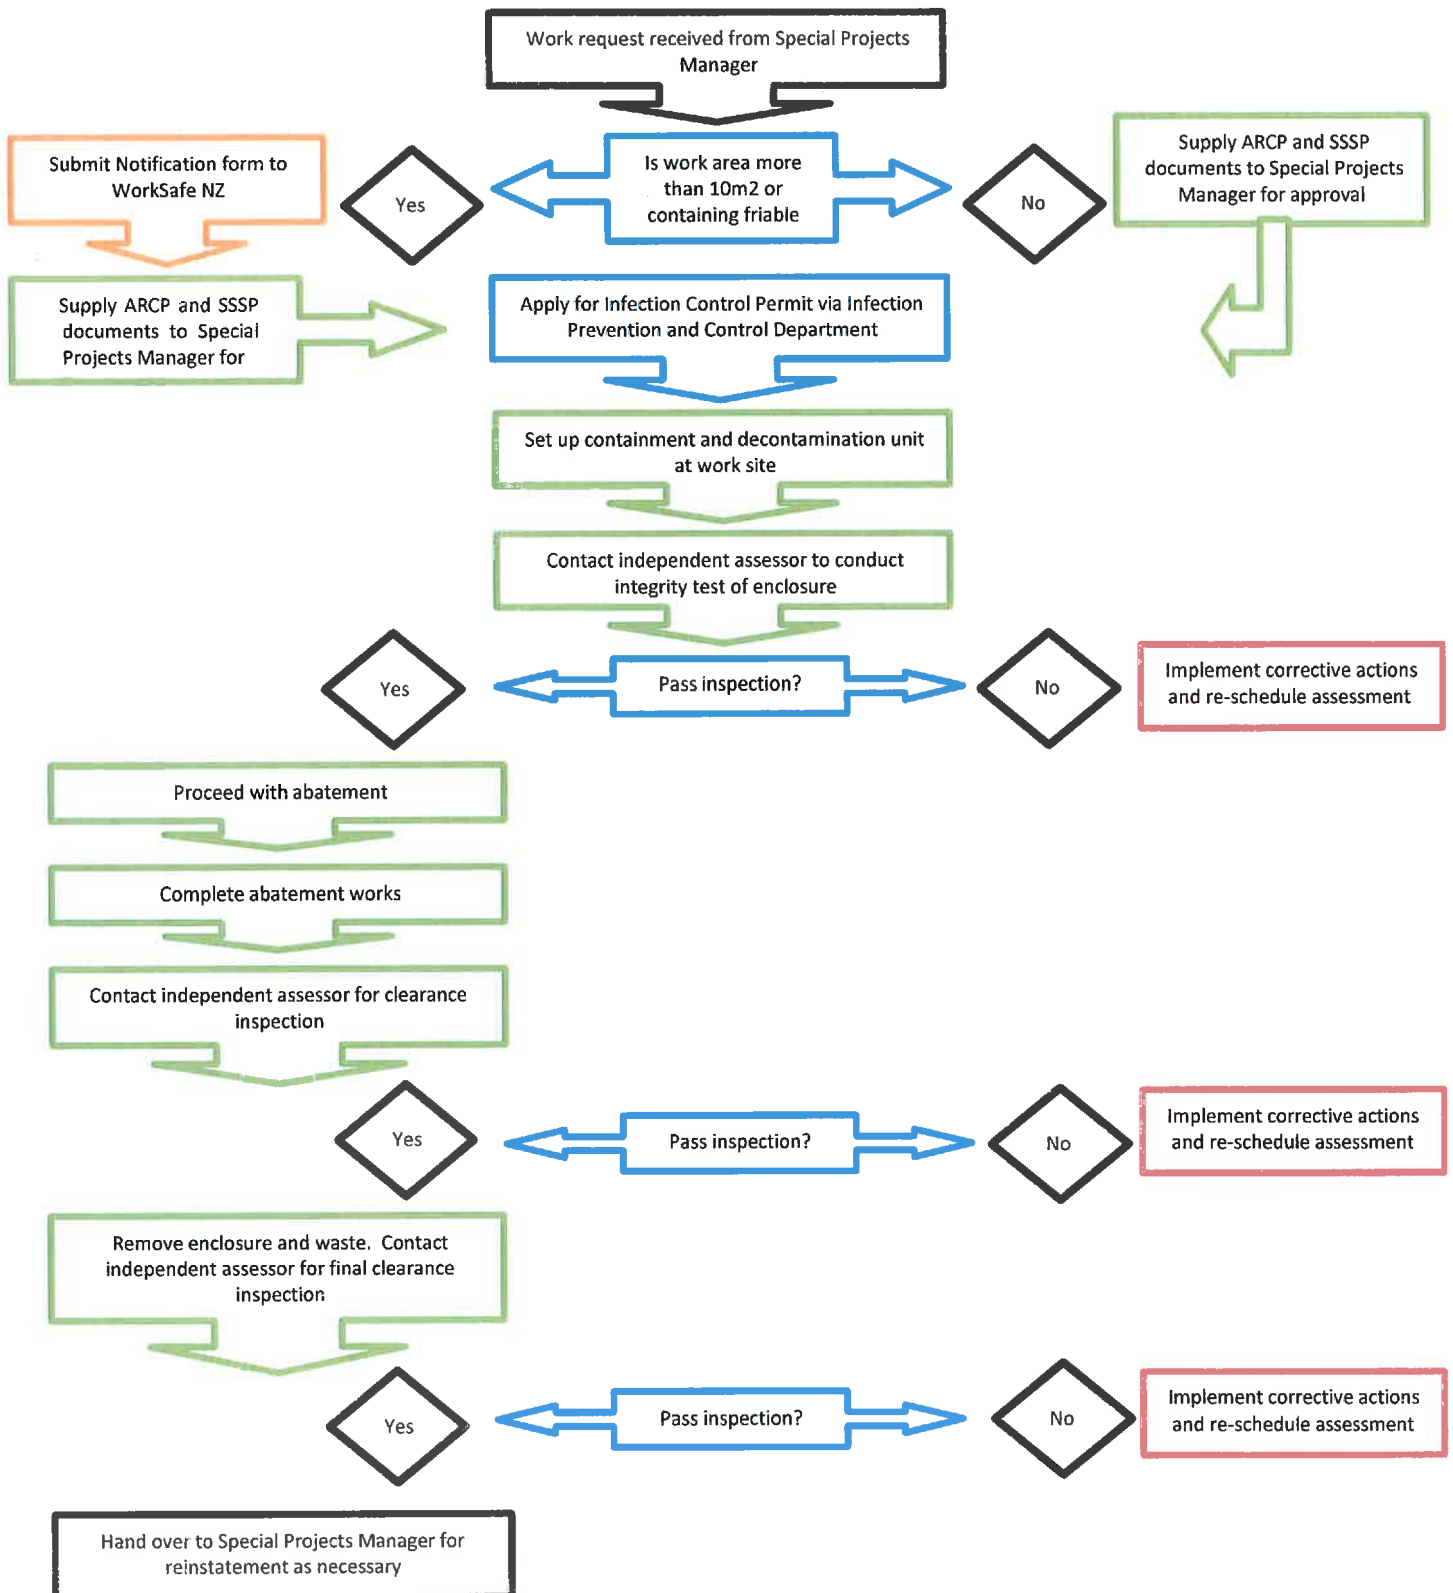
## 14. The Asbestos Abatement Process at Auckland DHB

The following flow chart describes the process undertaken when removing asbestos at ADHB sites in line with the current Asbestos Regulations.
